Quality Assurance and Source Inspection

Contract #: 04-0120F4Cty: SF/ALA Rte: 80 PM: 13.2/13.9File #: 69.28**WELDING INSPECTION REPORT****Resident Engineer:** Pursell, Gary**Address:** 333 Burma Road**City:** Oakland, CA 94607**Report No:** WIR-013021**Date Inspected:** 08-Apr-2010**Project Name:** SAS Superstructure**OSM Arrival Time:** 1900**Prime Contractor:** American Bridge/Fluor Enterprises, a JV**OSM Departure Time:** 700**Contractor:** Zhenhua Port Machinery Company, Ltd (ZPMC), Changxing Island **Location:** Shanghai, China**CWI Name:** See Below**CWI Present:** Yes No**Inspected CWI report:** Yes No N/A**Rod Oven in Use:** Yes No N/A**Electrode to specification:** Yes No N/A**Weld Procedures Followed:** Yes No N/A**Qualified Welders:** Yes No N/A**Verified Joint Fit-up:** Yes No N/A**Approved Drawings:** Yes No N/A**Approved WPS:** Yes No N/A**Delayed / Cancelled:** Yes No N/A**Bridge No:** 34-0006**Component:** OBG**Summary of Items Observed:**

WELDING INSPECTION REPORT

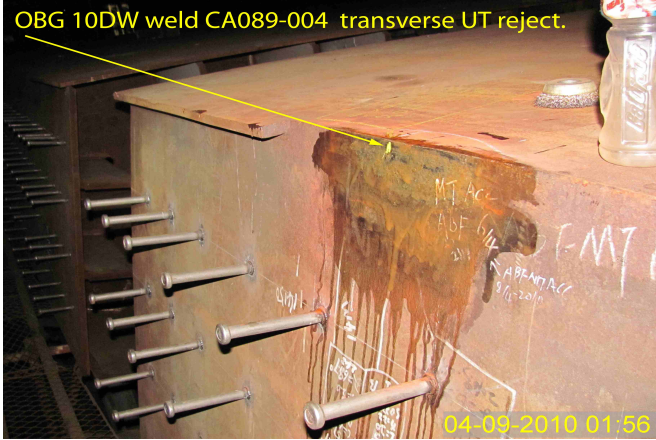
ABF issued "Inspection Notification Sheet" number 04082010-2 item #1 informing QA that on 4-08-2010 at 18:30 hours ABF Inspectors will be performing ultrasonic (UT) inspections of repaired weld CA089-004 which joins the deck plate and edge plate on the counterweight side of OBG 10DW. This weld is located in OBG Bay 14. Caltrans QA Inspector Mr. Mike Hasler was informed by ABF/Sense UT Inspectors that these weld repairs are UT acceptable. This QA Inspector performed ultrasonic inspections at the four weld repair locations as listed on the UT report data sheets for detection of longitudinal and planar transverse indications utilizing scanning patterns A, B, C and D (AWS D1.5 Fig 6.7) at "Y" locations 8275 mm, 8280 mm and 8285 mm appear to comply with project specifications and "Y" location 13950 mm appears to have a +7 class "A" rejectable indication transverse. Note: These inspections are being documented and tracked on "Verification Witness Request" documents and no TL-6027 UT report or incident report was issued for these inspections. See the photograph below for additional information.

OBG 10DW weld CA089-004 transverse UT reject.
